LArPix v1 testing

DUNE Pixel Readout Weekly Meeting

2019/5/9

Testing of chip packaging with v1 ASIC

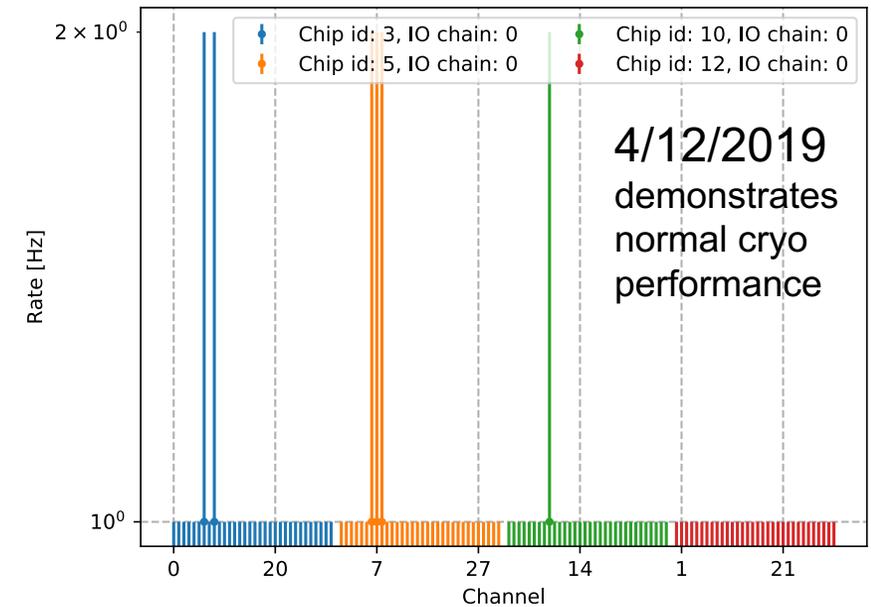
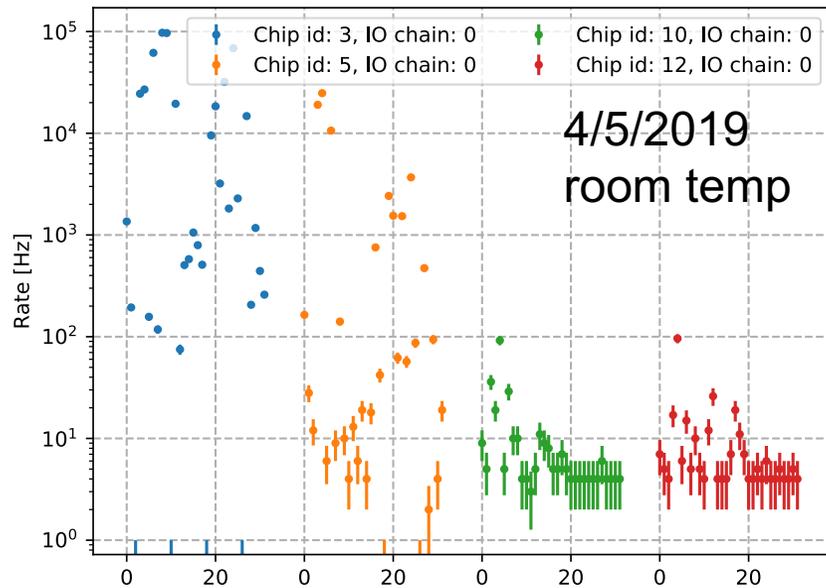
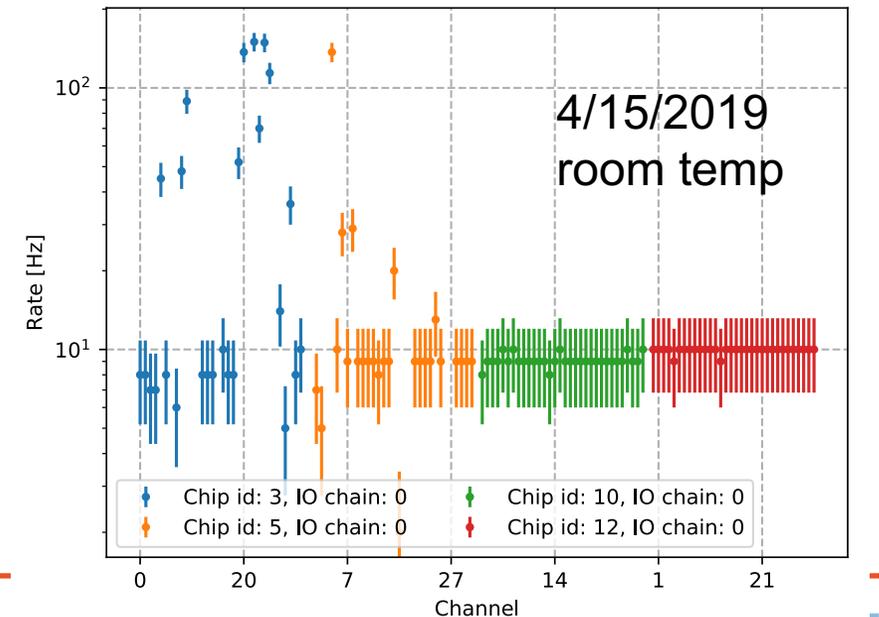
Time-varying leakage current

For 2/20 chips (chips 3, 5 of PCB4), observe time-dependent leakage current

- Initial testing showed very high leakage current that was not resolved with cleaning
- Subsequent tests show declining leakage current over the next 10 days

After 7 days, chips showed normal leakage at cold and only slightly elevated leakage at room temp.

10 days
→
>~1000x reduction

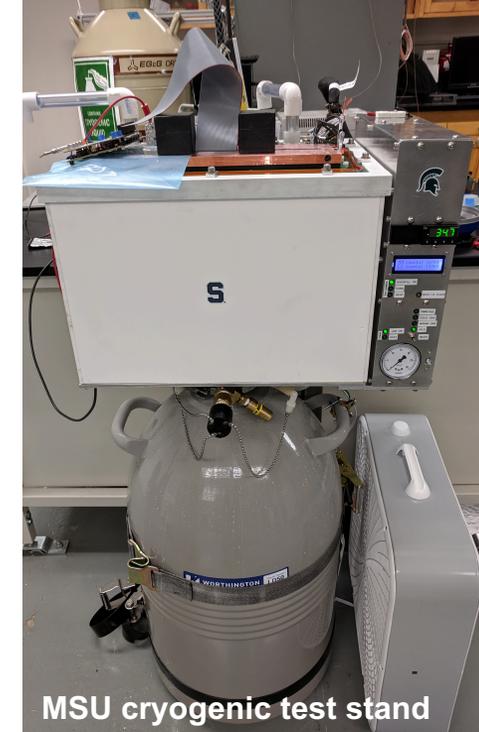
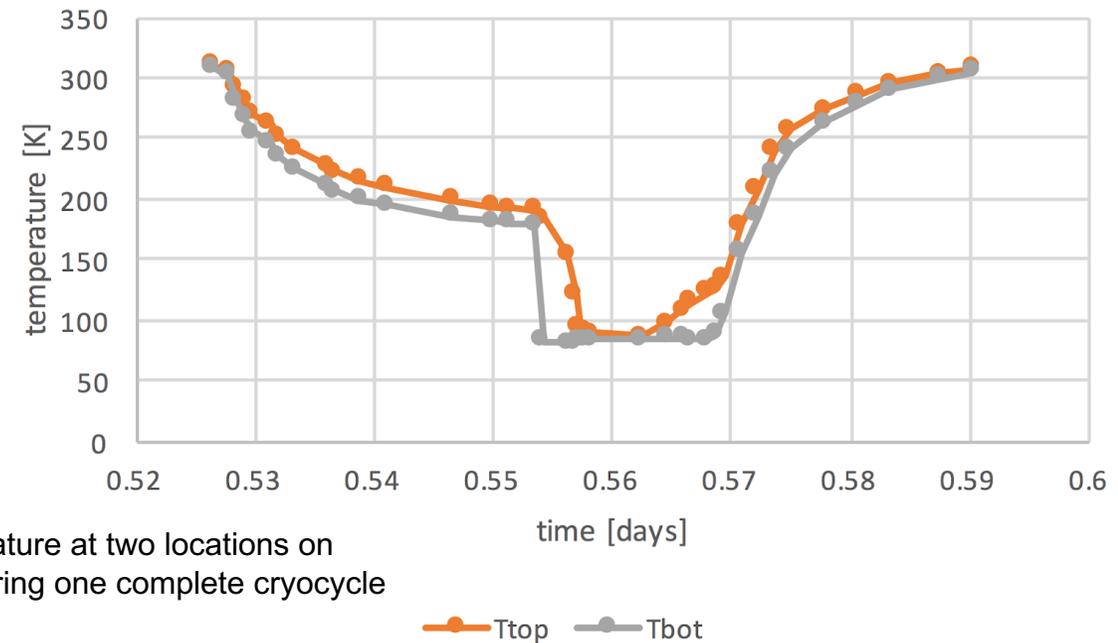
Cryogenic testing

Tested 19 remaining chips in LN2 bath

- No failures during cryocycle
- Noise and leakage performance is comparable to wire-bonded chips
- Multi-cycle testing of one board (4 chips) shows no failures after at least 5 rapid cryocycles
 - Note: failed header pin connector during rapid cycle testing

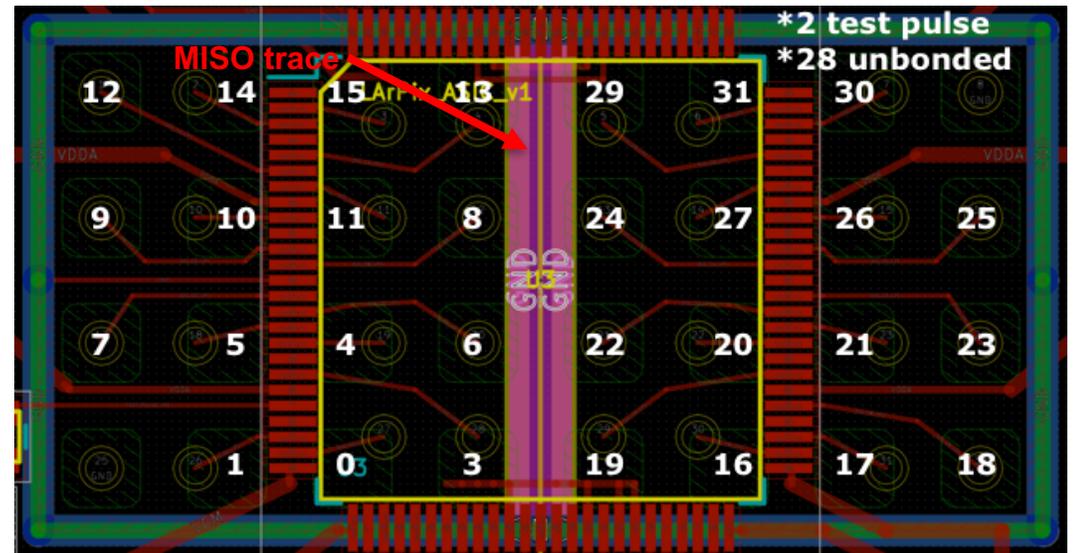
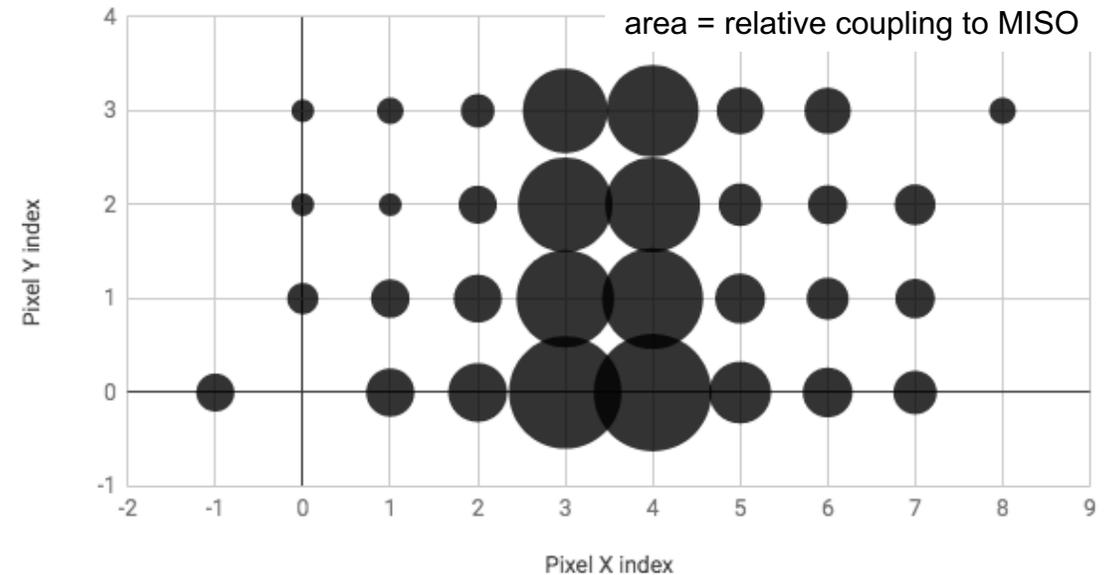
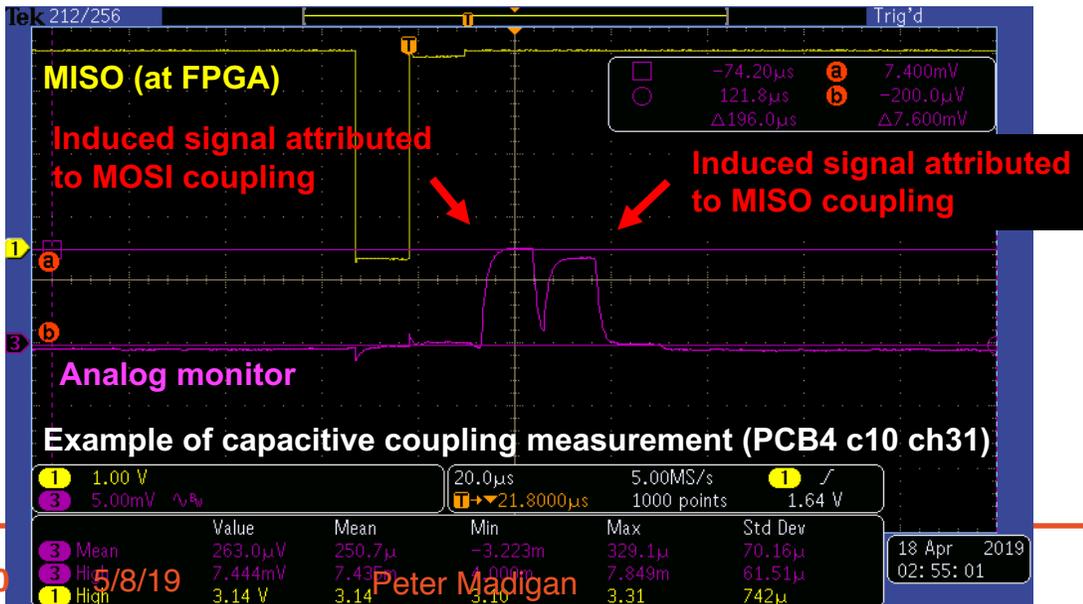
Capacitive pickup

Observed significant capacitive pickup from digital IO lines

Measured capacitance between MOSI/MISO and front-end to be $\sim 50\text{aF}$ (typical) to $\sim 1\text{fF}$ (worst)

Strongest coupling for channels adjacent to trace under chip

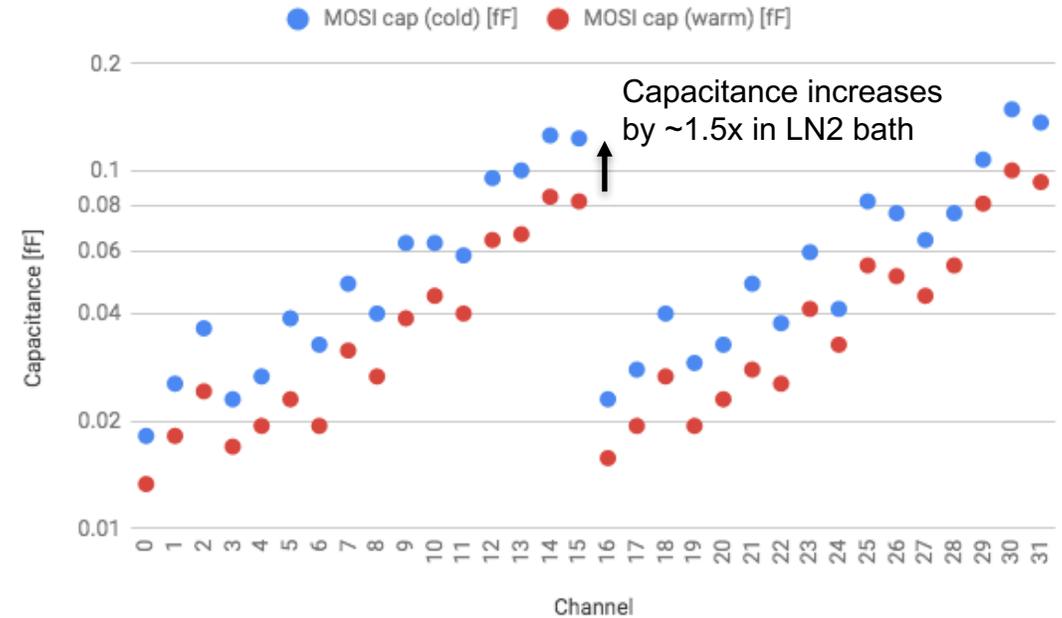
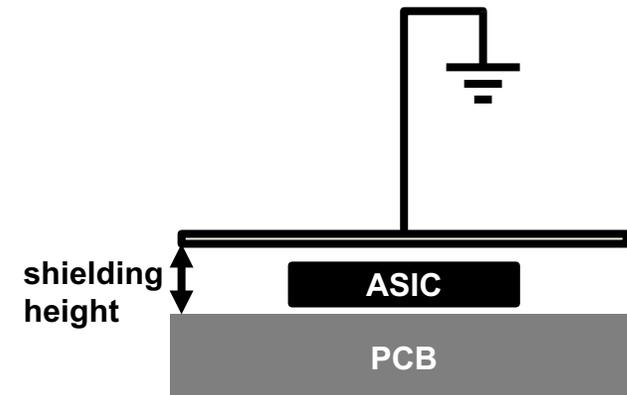
Capacitive pickup mitigation

Coupling increases $\sim 1.5x$ in LN2 suggesting that field lines exit chip packaging

Modification (PCB4 c10 ch28)	MISO coupling	MOSI coupling
None	2.8mV	4.5mV
Grounded plate @ 9mm	1.1mV	2.7mV
Grounded plate @ 2.5mm	<0.5mV	<0.5mV
Remove packaging foot	2.3mV	3.8mV

Tested mitigating capacitive pickup via grounded shield above chip

- v2 will also have the capability for differential signaling, further reducing capacitive effect

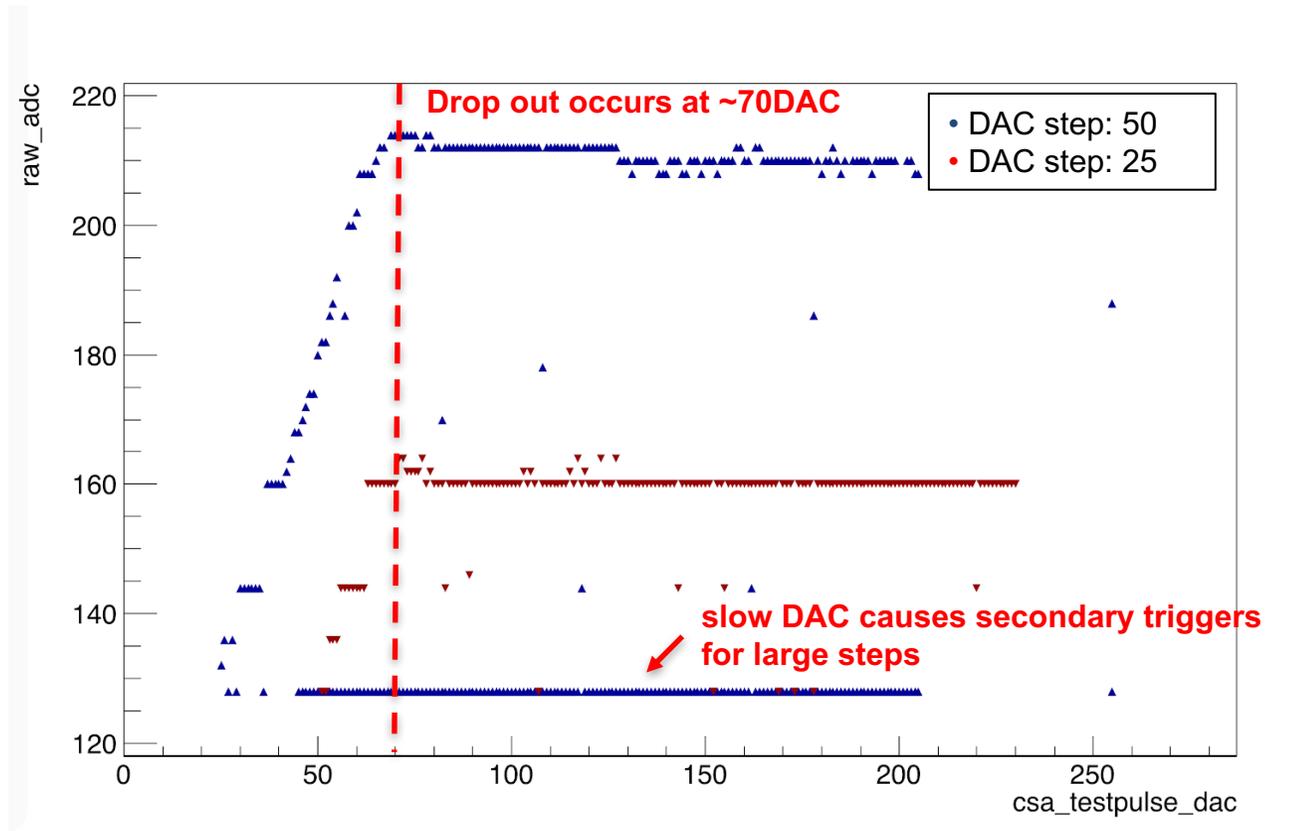
Pulse injection issues

- Testpulser DAC is slow
- Testpulser is non-linear for low DAC values ($< \sim 70$)

Temporary fix: Only test pulse in the upper half of DAC values

v2 fix: update DAC implementation to reduce drop out and increase speed

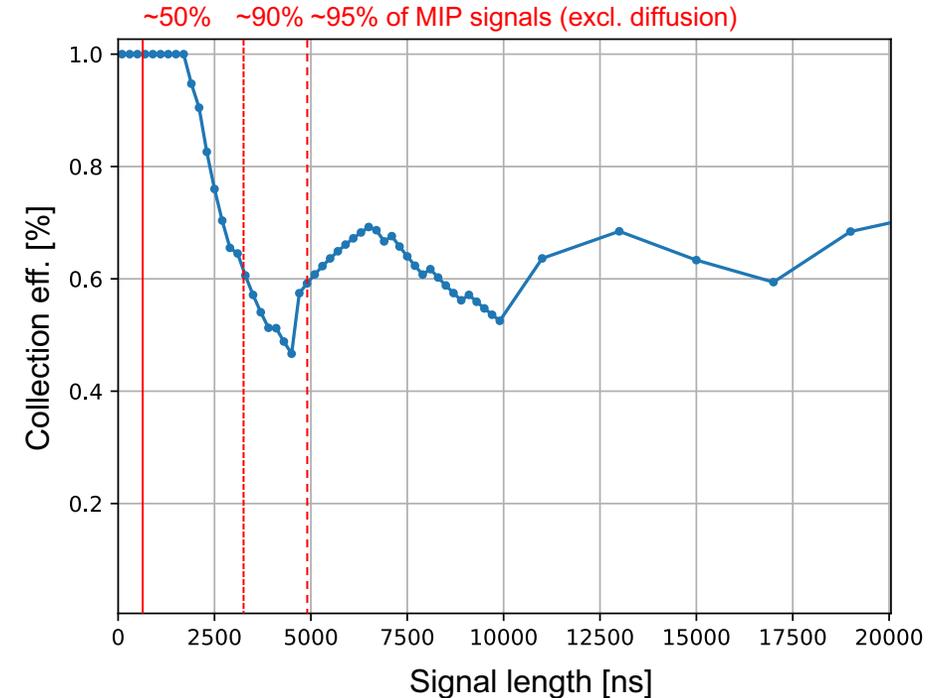
Issue: Channel reset occurs after ADC conversion

Consequences: Substantial dead time is introduced immediately following a channel trigger

Primitive simulation of charge loss due to dead-time:

- Utilize burst mode to digitize multiple times
- Increase digitization delay (sample_cycles)

v2 fix: Minor changes to the trigger logic
